INDIANA DEPARTMENT OF ENVIRONMENTAL MANAGEMENT

Re: Violation Letter

Indiana Transportation Museum

INDUSTRIAL/HAZARDOUS WASTE INSPECTION REPORT

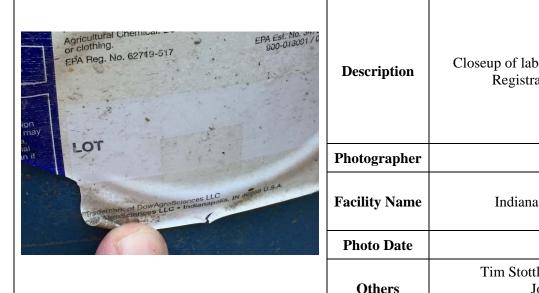
Number	10	
Description	Closeup of label in Photo 9 including the EPA Registration Number 62719-517.	
Photographer	Susan Lowry	
Facility Name	Indiana Transportation Museum	
Photo Date	June 9, 2017	
Others	Tim Stottlemyer- City of Noblesville John Naddy- IDEM Sarah Guss - Keramida Environmental

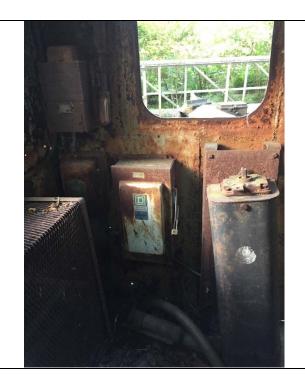
Number	11
Description	"Round house cab." Possible transformer (top left).
Photographer	Susan Lowry
Facility Name	Indiana Transportation Museum
Photo Date	June 9, 2017
Others	Tim Stottlemyer- City of Noblesville John Naddy- IDEM Sarah Guss - Keramida Environmental

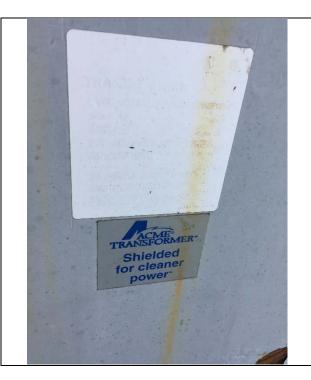
Number	12		
	Description	ACME Transformer label. There were several transformers located on the north end of the property. Label faded out.		
	Photographer	Susan Lowry		
	Facility Name	Indiana Transportation Museum		
	Photo Date	June 9, 2017		
Others		Tim Stottlemyer- City of Noblesville John Naddy- IDEM Sarah Guss - Keramida Environmental

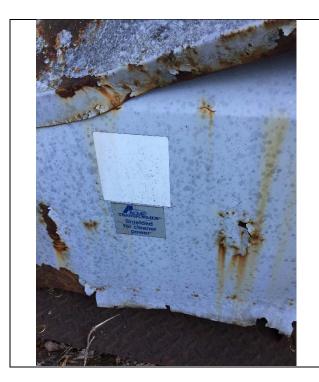
- o Ceramic electrical insulators previously used with an electric train/trolley.
- ACME Transformer Intact Dry Transformer.
- ACME Transformer Damaged Dry Transformer.

Number	13	
Description	Damaged ACME Transformer. ACME transformer label faded out.	
Photographer	Susan Lowry	
Facility Name	Indiana Transportation Museum	
Photo Date	June 9, 2017	
Others	Tim Stottlemyer- City of Noblesville John Naddy- IDEM Sarah Guss - Keramida Environmental

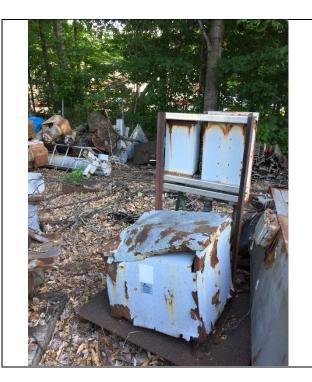
Number	14		
Description	Same transformer shown in Photo 13. North end of property.		
Photographer	Susan Lowry		
Facility Name	Indiana Transportation Museum		
Photo Date	June 9, 2017		
Others	Tim Stottlemyer- City of Noblesville John Naddy- IDEM Sarah Guss - Keramida Environmental

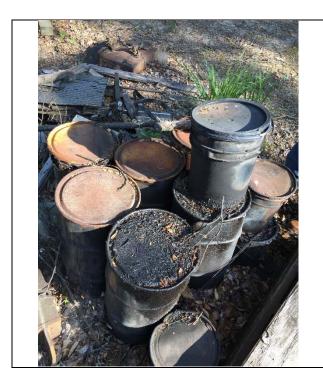
- On the ground around the assorted containers of 'gun grease'.
- Stained soil near the open containers between the semi-trailer containers.

Number	22	
Description	Several 5-gallon and 15-gallon containers. Facility representative said this is "gun grease" that has been on-site for at least ten years.	
Photographer	Susan Lowry	
Facility Name	Indiana Transportation Museum	
Photo Date	June 9, 2017	
Others	Tim Stottlemyer- City of Noblesville John Naddy- IDEM Sarah Guss - Keramida Environmental

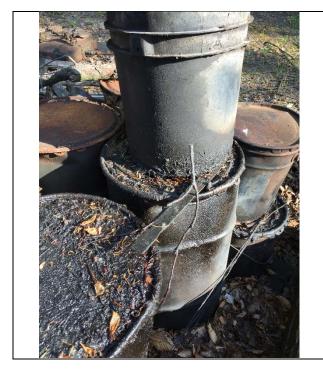
Number	24	
Description	Close up of "gun grease" containers in Photo 22.	
Photographer	Susan Lowry	
Facility Name	Indiana Transportation Museum	
Photo Date	June 9, 2017	
Others	Tim Stottlemyer- City of Noblesville John Naddy- IDEM Sarah Guss - Keramida Environmental

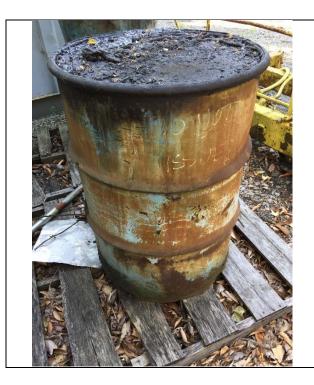
Number	28
Description	Close up of container in Photo 27. "Do not issue" marked on side of drum. Unknown material
Photographer	Susan Lowry
Facility Name	Indiana Transportation Museum
Photo Date	June 9, 2017
Others	Tim Stottlemyer- City of Noblesville John Naddy- IDEM Sarah Guss - Keramida Environmental

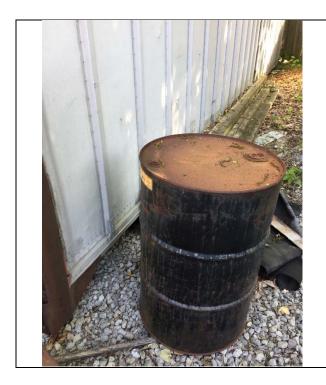
Number	32	
Description	55-gallon drum next to Trailer 800. Empty.	
Photographer	Susan Lowry	
Facility Name	Indiana Transportation Museum	
Photo Date	June 9, 2017	
Others	Tim Stottlemyer- City of Noblesville John Naddy- IDEM Sarah Guss - Keramida Environmental

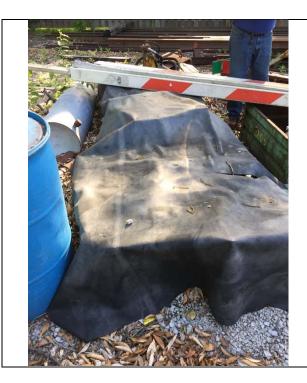
- Several brands/types. One type marked: 'Exide Ironclad Type ELM-240 Railway Cell'.
 - Some of the batteries are lead-acid batteries and (depending upon the physical condition) could be a universal waste or hazardous waste.

Number	34
Description	Lead-acid batteries under cover.
Photographer	Susan Lowry
Facility Name	Indiana Transportation Museum
Photo Date	June 9, 2017
Others	Tim Stottlemyer- City of Noblesville John Naddy- IDEM Sarah Guss - Keramida Environmental

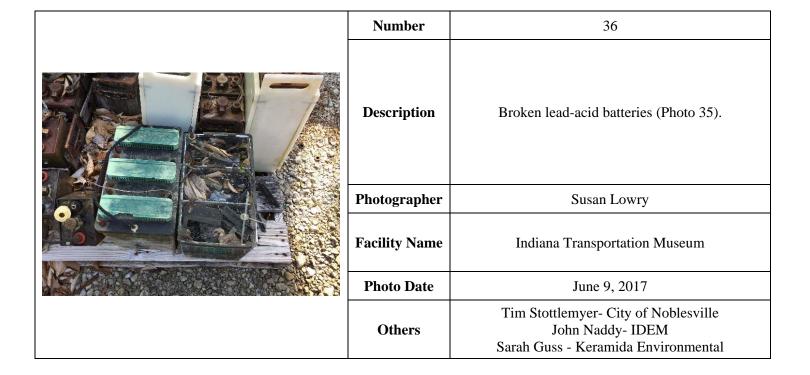
- Several broken batteries. Ranged from cracked casings to smashed batteries. If they were lead-acid batteries, this would be a release of a hazardous waste.
- Six 5-pound bags of Quikcrete Asphalt Patch.
 - o Stored on a wooden pallet, but the plastic bags are in poor condition.
- One 55-gallon container of AW 32 hydraulic oil stored in a horizontal cradle.
 - o A dispensing spigot is in the small bung hole.
 - o The large bunghole is open.
 - Stained soils were observed under the spigot.
- One 55-gallon blue plastic container unknown.
 - o Open, unlabeled.
 - o 3/4-filled.
- One 55-gallon plastic container.
 - o Product label- Zepride Cleaner Degreaser.
 - o Full.
- One 30-gallon plastic container.
 - o Unlabeled, unknown contents.
- Green Nitrogen Compressed Gas Cylinder.
 - o ≈ 4'+.
 - o Unknown if under pressure.
- One 55-gallon metal container.
 - o Empty.

Number	37
Description	Broken lead-acid batteries (Photo 35).
Photographer	Susan Lowry
Facility Name	Indiana Transportation Museum
Photo Date	June 9, 2017
Others	Tim Stottlemyer- City of Noblesville John Naddy- IDEM Sarah Guss - Keramida Environmental

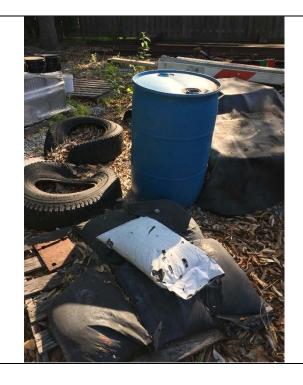
Number	42
Description	55-gallon drum, plastic. Open and approximately ¾ full. Bags in foreground are Quikcrete asphalt cold patch material.
Photographer	Susan Lowry
Facility Name	Indiana Transportation Museum
Photo Date	June 9, 2017
Others	Tim Stottlemyer- City of Noblesville John Naddy- IDEM Sarah Guss - Keramida Environmental

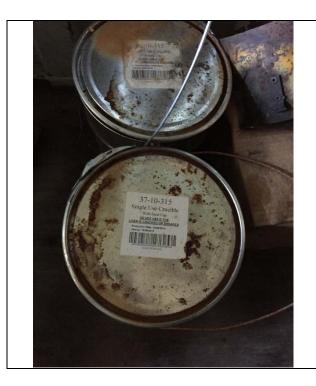
Number	43
Description	5-gallon containers in trailer 432004. Parts of Thermit Single Use Rail Welding Kits.
Photographer	Susan Lowry
Facility Name	Indiana Transportation Museum
Photo Date	June 9, 2017
Others	Tim Stottlemyer- City of Noblesville John Naddy- IDEM Sarah Guss - Keramida Environmental

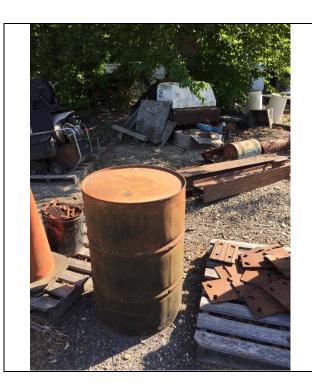
Number	47
Description	55-gallon drum, empty and upside down.
Photographer	Susan Lowry
Facility Name	Indiana Transportation Museum
Photo Date	June 9, 2017
Others	Tim Stottlemyer- City of Noblesville John Naddy- IDEM Sarah Guss - Keramida Environmental

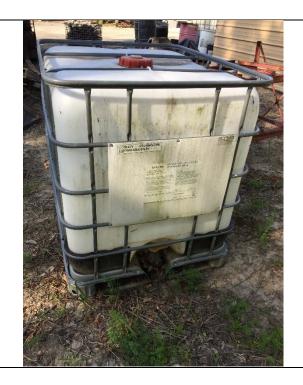
Number	48
Description	Tote - empty
Photographer	Susan Lowry
Facility Name	Indiana Transportation Museum
Photo Date	June 9, 2017
Others	Tim Stottlemyer- City of Noblesville John Naddy- IDEM Sarah Guss - Keramida Environmental

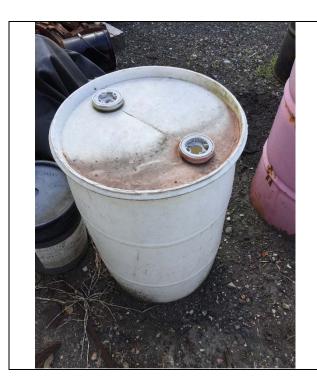
Number	49
Description	30-gallon poly container. Open and approximately ½ full. Unknown contents.
Photographer	Susan Lowry
Facility Name	Indiana Transportation Museum
Photo Date	June 9, 2017
Others	Tim Stottlemyer- City of Noblesville John Naddy- IDEM Sarah Guss - Keramida Environmental

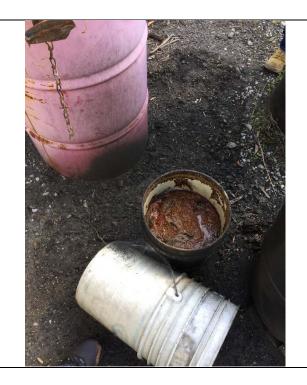
Number	50
Description	55-gallon drum, pink. Empty. 5-gallon pail, open. Approximately ¾ full, contents unknown.
Photographer	Susan Lowry
Facility Name	Indiana Transportation Museum
Photo Date	June 9, 2017
Others	Tim Stottlemyer- City of Noblesville John Naddy- IDEM Sarah Guss - Keramida Environmental

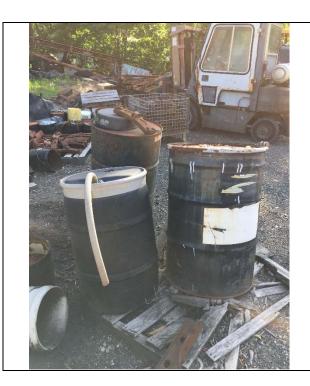
Number	51
Description	Three containers. One 55-gallon drum, one 45-gallon, and one 30-gallon drum (possibly sulphuric acid) with hose. The 45-gallon container was originally marked 'Dupont White Adhesion Promoter 76X6625'
Photographer	Susan Lowry
Facility Name	Indiana Transportation Museum
Photo Date	June 9, 2017
Others	Tim Stottlemyer- City of Noblesville John Naddy- IDEM Sarah Guss - Keramida Environmental

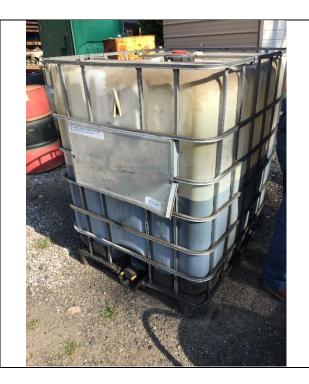
Number	52
Description	Tote outside tan shed, approximately ½ full. Marked 'Chevron 710 LE 20W40'
Photographer	Susan Lowry
Facility Name	Indiana Transportation Museum
Photo Date	June 9, 2017
Others	Tim Stottlemyer- City of Noblesville John Naddy- IDEM Sarah Guss - Keramida Environmental

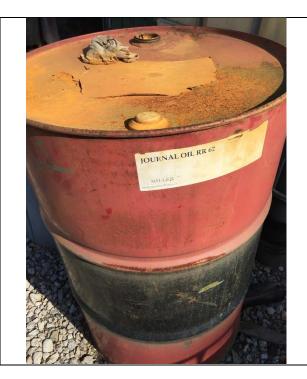
Number	54
Description	55-gallon drum of "Journal Oil RR 62" Located near tan shed.
Photographer	Susan Lowry
Facility Name	Indiana Transportation Museum
Photo Date	June 9, 2017
Others	Tim Stottlemyer- City of Noblesville John Naddy- IDEM Sarah Guss - Keramida Environmental

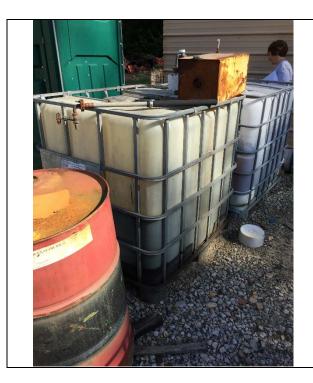
Number	55
Description	Tote near shed. Front tote labeled DDS Plus 9124 FM 9 TBN SAE 40. Tote in background is not labeled.
Photographer	Susan Lowry
Facility Name	Indiana Transportation Museum
Photo Date	June 9, 2017
Others	Tim Stottlemyer- City of Noblesville John Naddy- IDEM Sarah Guss - Keramida Environmental

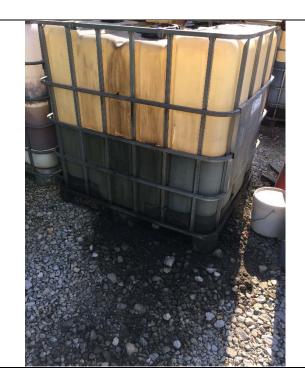
- Labeled Journal Oil RR62.
- One plastic tote (≈275 gallon).
 - o ½-filled.
 - o Marked 'DDS Plus 9124 FM9 TBN SAE 40 Railroad Engine Oil'.
 - Cracks observed in the plastic tote.

- o Stained soils observed around the tote.
- One plastic tote (≈275 gallon)
 - o ½-filled
 - o Unknown contents
 - o No markings/no labels
- One plastic tote (≈275 gallon)

Number	56
Description	Same tote as Photo 55 (I think). Tote has several cracks and evidence of leaks in the area.
Photographer	Susan Lowry
Facility Name	Indiana Transportation Museum
Photo Date	June 9, 2017
Others	Tim Stottlemyer- City of Noblesville John Naddy- IDEM Sarah Guss - Keramida Environmental

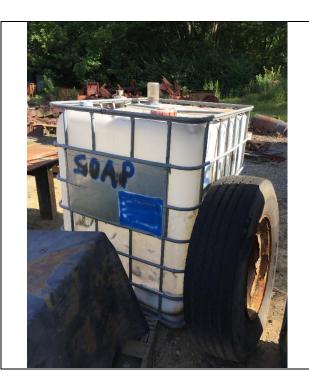
Number	57
Description	Soap tote is empty.
Photographer	Susan Lowry
Facility Name	Indiana Transportation Museum
Photo Date	June 9, 2017
Others	Tim Stottlemyer- City of Noblesville John Naddy- IDEM Sarah Guss - Keramida Environmental

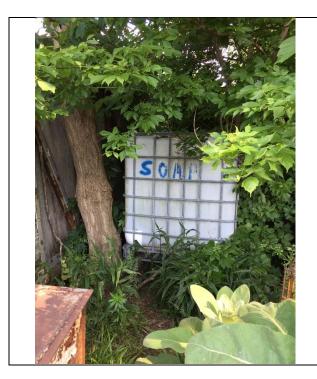
Number	Soap tote in wooded area.	
Description		
Photographer	Susan Lowry	
Facility Name	Indiana Transportation Museum	
Photo Date	June 9, 2017	
Others	Tim Stottlemyer- City of Noblesville John Naddy- IDEM Sarah Guss - Keramida Environmental

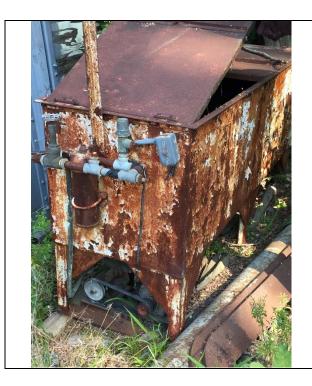
Number	61	
Description	Old parts washer- empty.	
Photographer	Susan Lowry	
Facility Name	Indiana Transportation Museum	
Photo Date	June 9, 2017	
Others	Tim Stottlemyer- City of Noblesville John Naddy- IDEM Sarah Guss - Keramida Environmental

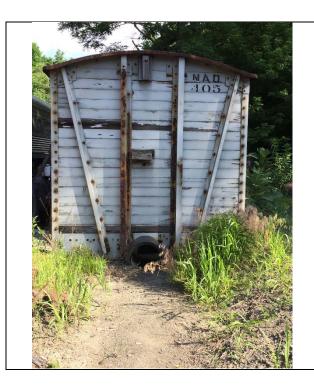
Number	62	
Description	What appears to be a drainage system under a rail car.	
Photographer	Susan Lowry	
Facility Name	Indiana Transportation Museum	
Photo Date	June 9, 2017	
Others	Tim Stottlemyer- City of Noblesville John Naddy- IDEM Sarah Guss - Keramida Environmental

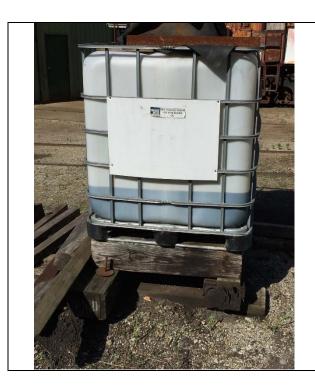
- o Unknown contents
- One 30-gallon container
 - o full
 - Unknown contents
- 1 plastic tote (≈275 gallon)
 - o 1/5-filled
 - Labeled: 'Multigrade RRDEO LSO 9 TBN Engine Oil'
 - o Post Inspection "RRDEO" Railroad Diesel Engine Oil. (May be a label for Safety Kleen or Cam2 oil.)
- One Diesel Fuel Tank (AST)
 - o In a metal secondary containment unit.
 - o No plug in secondary containment unit.
 - Staining from leakage observed.

Number	63	
Description	Tote – Labeled Multigrade RRDEO LSO 9TBN Engine Oil.	
Photographer	Susan Lowry	
Facility Name	Indiana Transportation Museum	
Photo Date	June 9, 2017	
Others	Tim Stottlemyer- City of Noblesville John Naddy- IDEM Sarah Guss - Keramida Environmental

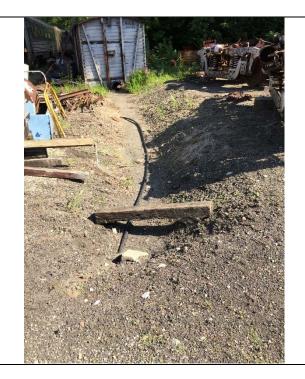
Number	64	
Description	Drainage system heading north toward the drain under the railcar. Believed to receive water pumped from the sump.	
Photographer	Susan Lowry	
Facility Name	Indiana Transportation Museum	
Photo Date	June 9, 2017	
Others	Tim Stottlemyer- City of Noblesville John Naddy- IDEM Sarah Guss - Keramida Environmental

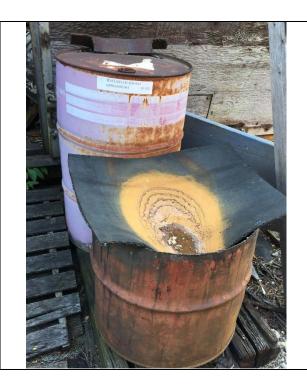
Number	69	
Description	55-gallon drum- Railroad RD 943 ½ 55-gallon drum, partially covered. Near "Oil Car."	
Photographer	Susan Lowry	
Facility Name	Indiana Transportation Museum	
Photo Date	June 9, 2017	
Others	Tim Stottlemyer- City of Noblesville John Naddy- IDEM Sarah Guss - Keramida Environmental

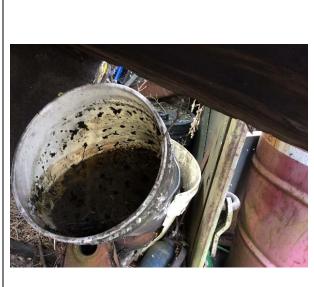
Number	73	
Description	Containers inside Oil Car.	
Photographer	Susan Lowry	
Facility Name	Indiana Transportation Museum	
Photo Date	June 9, 2017	
Others	Tim Stottlemyer- City of Noblesville John Naddy- IDEM Sarah Guss - Keramida Environmental

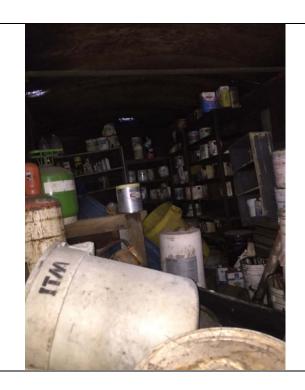
Number	74	
Description	Various containers inside the Oil Car looking north.	
Photographer	Susan Lowry	
Facility Name	Indiana Transportation Museum	
Photo Date	June 9, 2017	
Others	Tim Stottlemyer- City of Noblesville John Naddy- IDEM Sarah Guss - Keramida Environmental

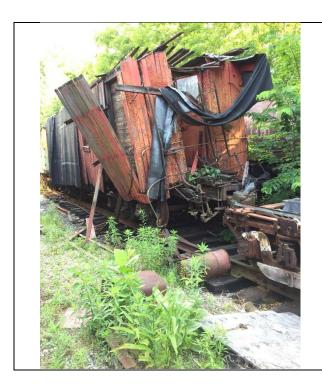
Number	80	
Description	Railcars in various stages of disrepair. Drum in foreground.	
Photographer	Susan Lowry	
Facility Name	Indiana Transportation Museum	
Photo Date	June 9, 2017	
Others	Tim Stottlemyer- City of Noblesville John Naddy- IDEM Sarah Guss - Keramida Environmental

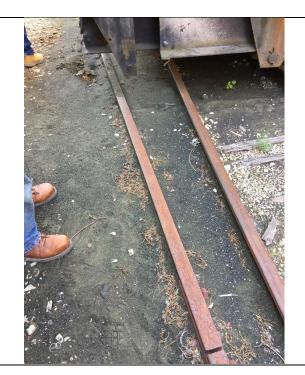
Number	89
Description	An accumulation of sandblast residue from sandblasting rail cars outside. Facility representative indicated this was last done in the 1990s. Area is around Tracks 5 and 6.
Photographer	Susan Lowry
Facility Name	Indiana Transportation Museum
Photo Date	June 9, 2017
Others	Tim Stottlemyer- City of Noblesville John Naddy- IDEM Sarah Guss - Keramida Environmental

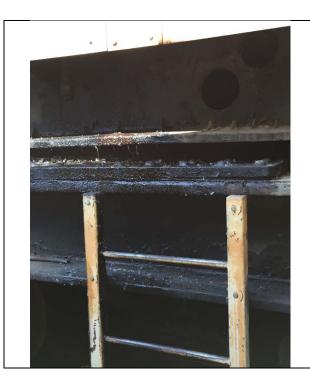
- Around the entrance of the 'Oil Car'.
- Oil/grease being released from around the 'Yellow Engine.'
- Oil from a crane located at the north end of the rail yard.
- Grease from the gears of a crane-car located north of the main building.
- Black substance spilled in Trailer 800.
- Blasting media on the track north of the main building.
- Stained soils from materials draining from the diesel fuel AST secondary containment.
- Staining on the ground next to the cracked tote near the partially erected metal shed.
- Stained soils beneath a spigot on a 55-gallon container marked AW-32 hydraulic oil.
- Smashed batteries in various locations on the property.

Number	90
Description	Grease leaking from crane on track 5. Identified by the facility representative as grease leaking from the lubed gears and cables on the crane.
Photographer	Susan Lowry
Facility Name	Indiana Transportation Museum
Photo Date	June 9, 2017
Others	Tim Stottlemyer- City of Noblesville John Naddy- IDEM Sarah Guss - Keramida Environmental

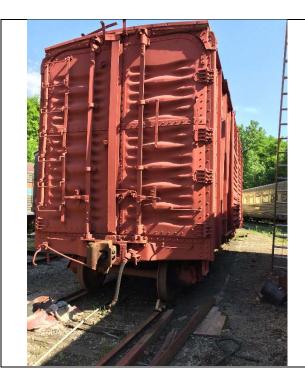
Number	91
Description	A "recently" refurbished boxcar. Facility representative stated it was painted approximately four years ago. Track 6. Boxcar contains carpet, chairs, and some 1-gallon and 5-gallon containers of primers, paints and adhesives.
Photographer	Susan Lowry
Facility Name	Indiana Transportation Museum
Photo Date	June 9, 2017
Others	Tim Stottlemyer- City of Noblesville John Naddy- IDEM Sarah Guss - Keramida Environmental

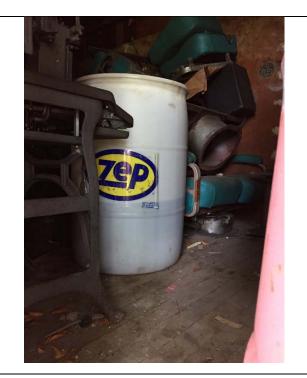
Number	93	
Description	A 55-gallon drum located in the Swift Premium refrigerated car, located on track 6. This is one of the cars on display at the museum.	
Photographer	Susan Lowry	
Facility Name	Indiana Transportation Museum	
Photo Date	June 9, 2017	
Others	Tim Stottlemyer- City of Noblesville John Naddy- IDEM Sarah Guss - Keramida Environmental Les McConnell - ITM

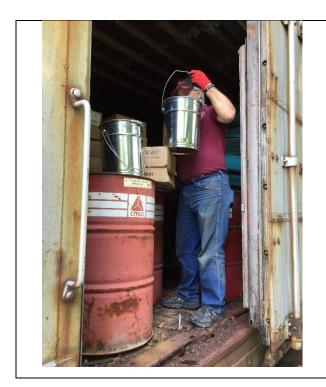
- The containers were Labeled Citgo Railroad RD 943.
- Staff determined that the accessible containers were empty.
- The rail car also contained approximately 20 boxes of Thermit single-use thermite welding kits used to weld broken steel tracks.
- The Thermit kits contain metal fines and metal oxide powders.
- The Thermit kits were out of date and were to be used by 2010.

Number	94
Description	The Swift Premium refrigerated car, located on track 6. The facility representative is handling Thermit Single Use Track Welding kits.
Photographer	Susan Lowry
Facility Name	Indiana Transportation Museum
Photo Date	June 9, 2017
Others	Tim Stottlemyer- City of Noblesville John Naddy- IDEM Sarah Guss - Keramida Environmental Les McConnell - ITM

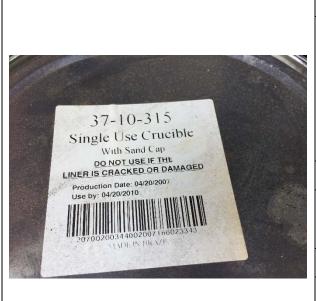
Number	95
Description	One of the lids from the Thermite Crucibles stored in the Swift Premium rail car. Thermite is used for track repair. The crucibles were approximately 2-3 gallons, and there were approximately nine crucibles stored in this car. This label indicates a "use by" date of 4/20/2010.
Photographer	Susan Lowry
Facility Name	Indiana Transportation Museum
Photo Date	June 9, 2017
Others	Tim Stottlemyer- City of Noblesville John Naddy- IDEM Sarah Guss - Keramida Environmental Les McConnell - ITM

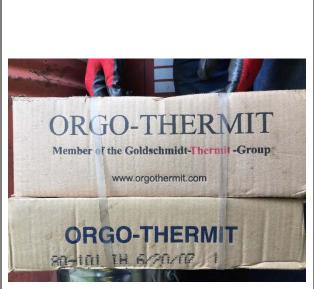
Number	97
Description	Part of the single use track welding repair kits stored in the Swift Premium refrigerator car. Dated 6/20/07.
Photographer	Susan Lowry
Facility Name	Indiana Transportation Museum
Photo Date	June 9, 2017
Others	Tim Stottlemyer- City of Noblesville John Naddy- IDEM Sarah Guss - Keramida Environmental Les McConnell - ITM

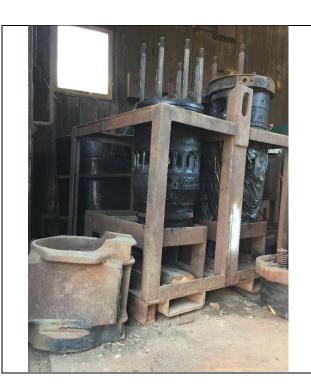
Number	98
Description	Several 55-gallon containers located in the north end of the Crane Naval Weapons Car. Additional 55-gallon containers were located in the southern end of the car.
Photographer	Susan Lowry
Facility Name	Indiana Transportation Museum
Photo Date	June 9, 2017
Others	Tim Stottlemyer- City of Noblesville John Naddy- IDEM Sarah Guss - Keramida Environmental

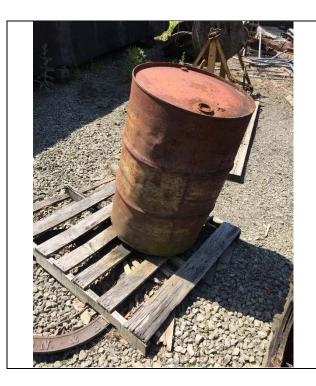
Number	103
Description	55-gallon drum, in yard east of building. Empty.
Photographer	Susan Lowry
Facility Name	Indiana Transportation Museum
Photo Date	June 9, 2017
Others	Tim Stottlemyer- City of Noblesville John Naddy- IDEM Sarah Guss - Keramida Environmental

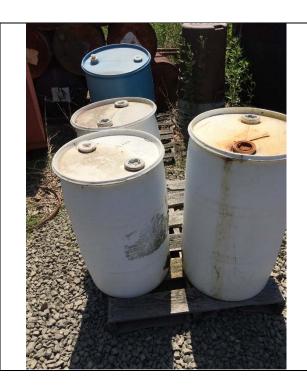
Number	104
Description	Three containers in the yard east of the building. One 55-gallon, two 30-gallon. All contain material, contents unknown.
Photographer	Susan Lowry
Facility Name	Indiana Transportation Museum
Photo Date	June 9, 2017
Others	Tim Stottlemyer- City of Noblesville John Naddy- IDEM Sarah Guss - Keramida Environmental

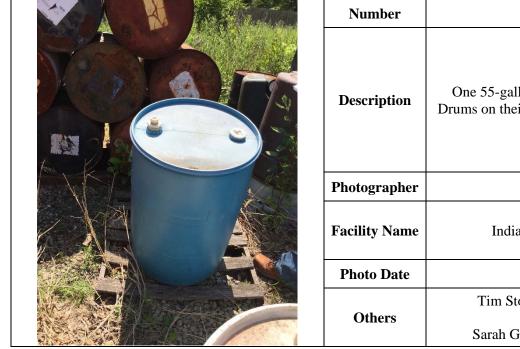
Number	106	
Description	One 55-gallon drum, contents unknown. Full. Drums on their sides in the background are empty.	
Photographer	Susan Lowry	
Facility Name	Indiana Transportation Museum	
Photo Date	June 9, 2017	
Others	Tim Stottlemyer- City of Noblesville John Naddy- IDEM Sarah Guss - Keramida Environmental
