INDIANA DEPARTMENT OF ENVIRONMENTAL MANAGEMENT

Re: Violation Letter

Indiana Transportation Museum

INDUSTRIAL/HAZARDOUS WASTE INSPECTION REPORT

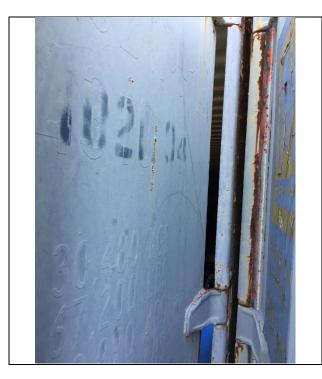
Number	44
Description	Trailer number 432004.
Photographer	Susan Lowry
Facility Name	Indiana Transportation Museum
Photo Date	June 9, 2017
Others	Tim Stottlemyer- City of Noblesville John Naddy- IDEM Sarah Guss - Keramida Environmental

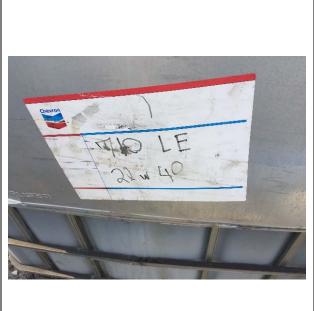
Number	53
Description	Label on back of tote in Photo 52.
Photographer	Susan Lowry
Facility Name	Indiana Transportation Museum
Photo Date	June 9, 2017
Others	Tim Stottlemyer- City of Noblesville John Naddy- IDEM Sarah Guss - Keramida Environmental

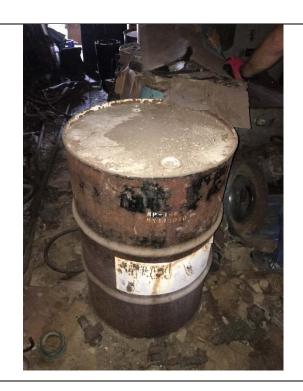
-
Number	108
Description	Photos 108-112 were taken by Mr. Stottlemyer, from inside a railcar identified as being from Crane. Mr. Stottlemyer stated all drums were partially full or full, and labels could not be read. IDEM staff did not enter this rail car.
Photographer	Tim Stottlemyer- City of Noblesville
Facility Name	Indiana Transportation Museum
Photo Date	June 9, 2017
Others	Les McConnell – ITM Tim Stottlemyer- City of Noblesville John Naddy- IDEM

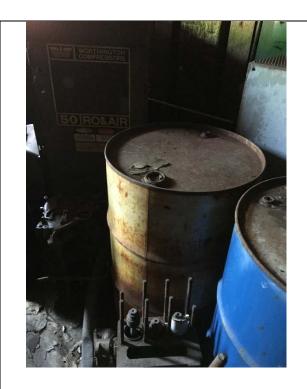
Number	109
Description	Photos 108-112 were taken by Mr. Stottlemyer, from inside a railcar identified as being from Crane. Mr. Stottlemyer stated all drums were partially full or full, and labels could not be read. IDEM staff did not enter this rail car.
Photographer	Susan Lowry
Facility Name	Indiana Transportation Museum
Photo Date	June 9, 2017
Others	Les McConnell – ITM Susan Lowry - IDEMTim Stottlemyer- City of Noblesville John Naddy- IDEM

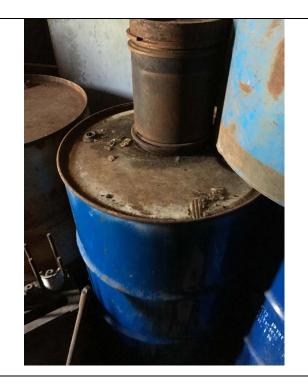
Number	110
Description	Photos 108-112 were taken by Mr. Stottlemyer, from inside a railcar identified as being from Crane. Mr. Stottlemyer stated all drums were partially full or full, and labels could not be read. IDEM staff did not enter this rail car.
Photographer	Susan Lowry
Facility Name	Indiana Transportation Museum
Photo Date	June 9, 2017
Others	Les McConnell – ITM Susan Lowry - IDEM Tim Stottlemyer- City of Noblesville John Naddy- IDEM

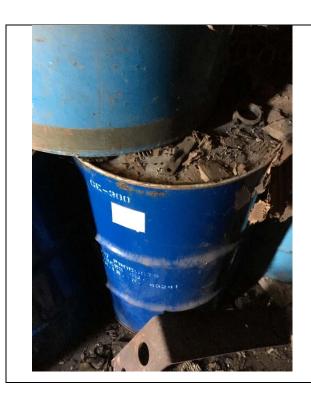
Number	111
Description	Photos 108-112 were taken by Mr. Stottlemyer, from inside a railcar identified as being from Crane. Mr. Stottlemyer stated all drums were partially full or full, and labels could not be read. IDEM staff did not enter this rail car.
Photographer	Tim Stottlemyer- City of Noblesville
Facility Name	Indiana Transportation Museum
Photo Date	June 9, 2017
Others	Les McConnell – ITM Susan Lowry - IDEM Tim Stottlemyer- City of Noblesville John Naddy- IDEM

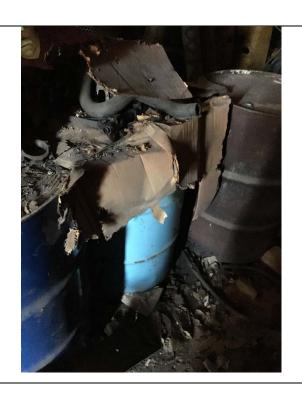
Number	112
Description	Photos 108-112 were taken by Mr. Stottlemyer, from inside a railcar identified as being from Crane. Mr. Stottlemyer stated all drums were partially full or full, and labels could not be read. IDEM staff did not enter this rail car.
Photographer	Susan Lowry
Facility Name	Indiana Transportation Museum
Photo Date	June 9, 2017
Others	Les McConnell – ITM Susan Lowry - IDEM Tim Stottlemyer- City of Noblesville John Naddy- IDEM

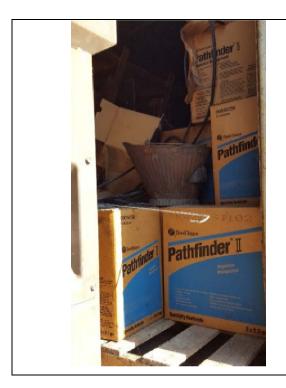
Number	121
Description	Silver Rail Car An unknown number of cases of Pathfinder II herbicide. 5 gallons per case in 2 2.5-gallon containers. The herbicide was produced in 8/1996 by DowElanco. The current SDS for that product indicates that it is stable for 24 months when stored under controlled conditions. This material is almost 21 years old and has been stored in less than ideal conditions.
Photographer	Scott Draschil - IDEM
Facility Name	Indiana Transportation Museum
Photo Date	June 9, 2017
Others	Tim Stottlemyer- City of Noblesville

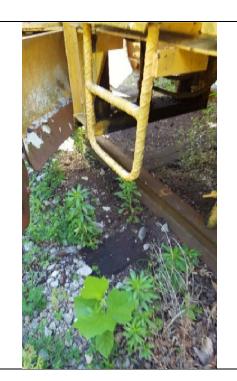
Number	122
Description	Stained soil around the tracks at the base of a yellow railroad engine on Track 3 at the north end of the rail yard.
Photographer	Scott Draschil - IDEM
Facility Name	Indiana Transportation Museum
Photo Date	June 9, 2017
Others	Tim Stottlemyer- City of Noblesville

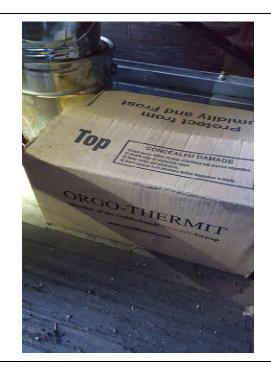
Number	125
Description	Part of a single use track welding repair kit in Trailer N0SU440606 8 SG 4310
Photographer	Scott Draschil
Facility Name	Indiana Transportation Museum
Photo Date	June 9, 2017
Others	Tim Stottlemyer- City of Noblesville John Naddy- IDEM

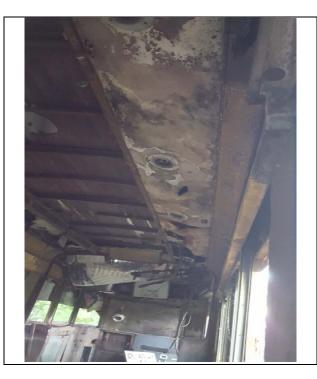
Number	126
Description	Potential asbestos containing material in the rail car informally referred to as the 'Asbestos Car'
Photographer	Susan Lowry Draschil
Facility Name	Indiana Transportation Museum
Photo Date	June 9, 2017
Others	Tim Stottlemyer- City of Noblesville John Naddy- IDEM

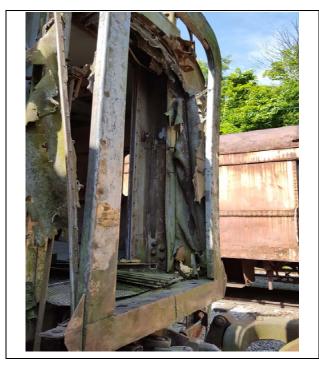
Number	127
Description	Potentially asbestos containing material on one of the cabooses.
Photographer	Scott Draschil
Facility Name	Indiana Transportation Museum
Photo Date	June 9, 2017
Others	Tim Stottlemyer- City of Noblesville John Naddy- IDEM

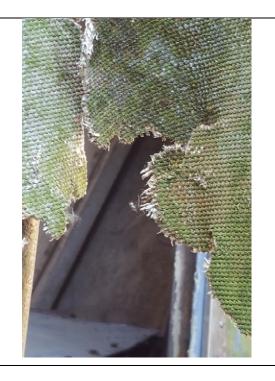
Number	128
Description	Close up of potentially asbestos containing material on the caboose.
Photographer	Scott Draschil
Facility Name	Indiana Transportation Museum
Photo Date	June 9, 2017
Others	Tim Stottlemyer- City of Noblesville John Naddy- IDEM

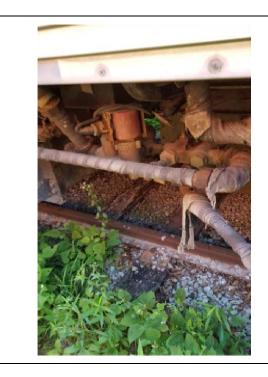
Number	130				
Description	Potentially asbestos containing pipe wrap on a rail car on track 3.				
Photographer	Scott Draschil				
Facility Name	Indiana Transportation Museum				
Photo Date	June 9, 2017				
Others	Tim Stottlemyer- City of Noblesville John Naddy- IDEM

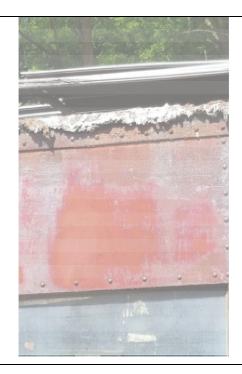
Number	131				
Description	Potentially asbestos containing material on a rail car on track 3.				
Photographer	Scott Draschil				
Facility Name	Indiana Transportation Museum				
Photo Date	June 9, 2017				
Others	Tim Stottlemyer- City of Noblesville John Naddy- IDEM
